OPERATING EXPERIENCE WEEKLY SUMMARY

Office of Nuclear and Facility Safety

January 30 through February 5, 1998

Summary 98-05

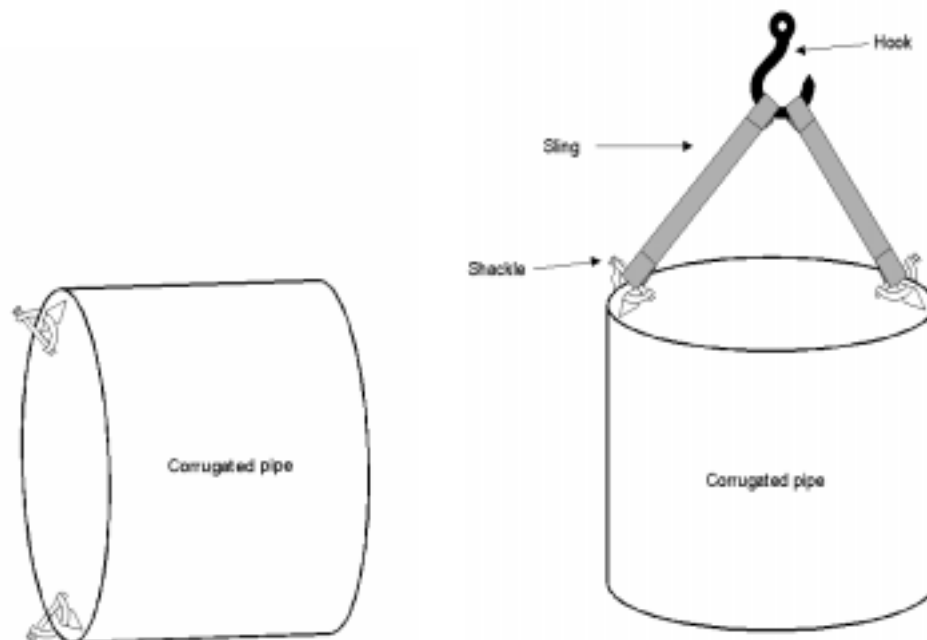
Figure 6-1. Rigging Arrangement (not to scale)

Figure 6-1 shows the rigging arrangement used for the lift. The riggers lifted the pipe twice during installation. After excavators dug a hole for placement of the pipe, the riggers lifted it and placed it vertically into the hole. However, project personnel realized that more excavation was needed, so the riggers removed the pipe and placed it horizontally on the ground. After additional excavation, riggers started a second lift to the vertical position, and one of the slings failed. The pipe was suspended by the remaining sling, and riggers were able to safely lower it to the ground.

Investigators determined that the riggers inspected the slings before the lift and found them in good condition. After inspecting the failed sling, investigators determined that it probably was cut by the edge of the pipe as it was being positioned. They also determined that the failed sling was rated for 3,200 pounds, but the lift plan specified a 4,800-pound-capacity sling. The actual weight of the pipe was 3,771 pounds. Investigators learned that the subcontractor purchased new nylon slings rated for 6,400-pound-capacity and used them to complete the job of lowering the pipe into the hole.

These events illustrate the importance of ensuring that the rigging is not exposed to sharp edges and that the load does not exceed the rated capacity of the hoisting and rigging equipment. Dropped loads can be extremely hazardous. DOE-STD-1090-96 (rev 1), *Hoisting and Rigging*, provides guidance for hoisting and rigging and identifies related codes, standards, and regulations. The following guidance applies to this event.

- Section 11.3.5, "Synthetic-Web Slings," specifies requirements for nylon slings and includes requirements for protecting slings from sharp-cornered objects and for proof-testing. The standard allows for proof-testing by the manufacturer if the manufacturer provides certification that the sling was proof-tested to 200 percent of rated capacity.
